MEMORANDUM

SUBJECT: ACTION MEMORANDUM - Request for a Time-Critical Removal Action at the Cincinnati Die Cast Site, Cincinnati, Hamilton County, Ohio (Site ID #B5TZ)

Cincinnati Die Cast Site
Cincinnati, Hamilton County, OH
November 2009

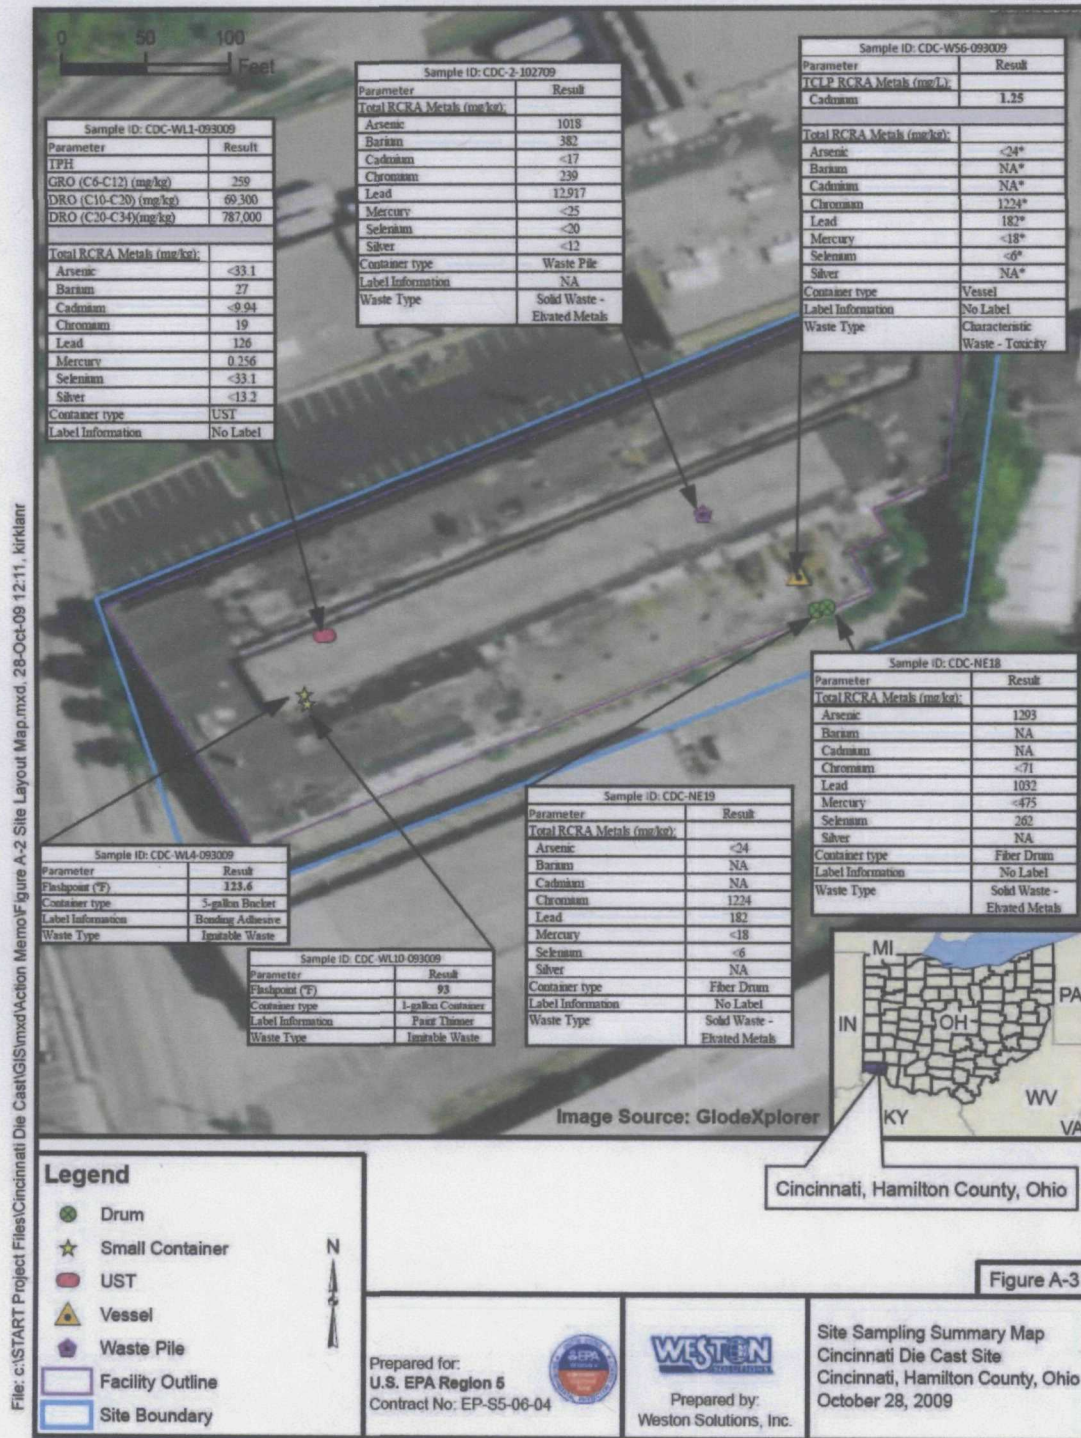
FIGURE A-3
SAMPLE SUMMARY MAP

U.S. EPA Site Investigation XRF readings and sampling results are found in Table 1.

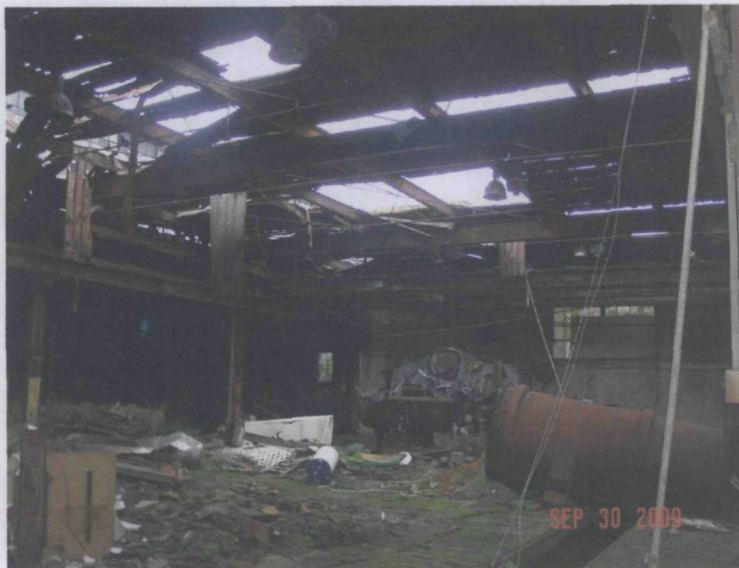
FIGURE A-4

During the U.S. EPA Site Investigation, the On-Scene Coordinator (OSC) and START contractor noted a structurally-impaired Site building. The structurally-impaired building is approximately 58,000 square feet, with the roof collapsed in numerous areas. Uncontainerized waste piles surrounded the furnaces and coolant trenches were filled with oil, water, and debris. Numerous unknown drums and containers were documented inside the vacant building. The OSC noted unrestricted Site access with doors and windows broken. Debris including drums,

Above: View of furnace area and roof damage

5. Dismantle and decontaminate process equipment, tanks and building components associated with the product process area, as necessary;
6. Transport and dispose of all characterized or identified hazardous substances, pollutants, wastes, or contaminants to a RCRA/CERCLA-approved disposal facility in accordance with U.S. EPA's Off-Site Rule (40 CFR § 300.440).

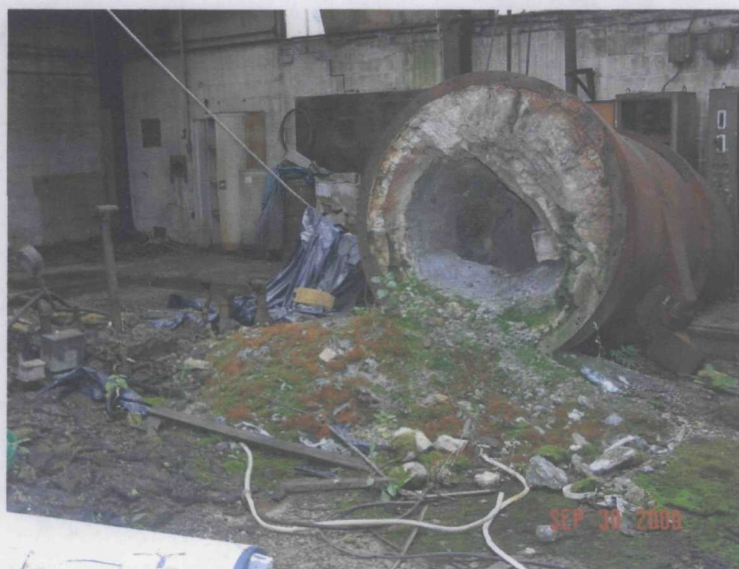
- Sample CDC-WS6-093009 had a Toxicity Characteristic Leaching Procedure (TCLP) cadmium concentration of 1.25 mg/L, which exceeds the TCLP cadmium regulatory level of 1.0 mg/L, and defines the waste as characteristic hazardous waste for toxicity under the Resource Conservation and Recovery Act (RCRA) 40 CFR §261.24.
- Samples CDC-WL4-09309 and CDC-WL10-09309 had flashpoint results of 123.6 °F and 93 °F respectively. These results are less than the flashpoint regulatory level of 140 °F, and define the wastes as characteristic hazardous wastes for ignitability under RCRA

During EPA Site Investigation activities, EPA and START observed and documented the presence of two deteriorated furnaces (ranging in size from 1,000 – 2,000 gallons) with spilled contents and approximately 75 drums and small containers of material located throughout the building. Additionally, a large UST was sampled and contained waste oil. EPA samples confirmed the presence of ignitable, TCLP cadmium hazardous waste at the Site. Drums and uncontainerized waste piles are uncovered, deteriorated, and/or leaking. Further deterioration of the drums may allow additional quantities of hazardous substances to migrate into the environment. Because of these factors, hazardous substances, pollutants, and contaminants in varying forms and quantities have been documented to exist on the Site.

Above: View of furnace waste pile containing cadmium.

3. Inventory and perform hazard characterization on all substances contained in containers, drums, waste piles, and tanks;
4. Consolidate and package all hazardous substances, pollutants and contaminants for transportation and off-site disposal;

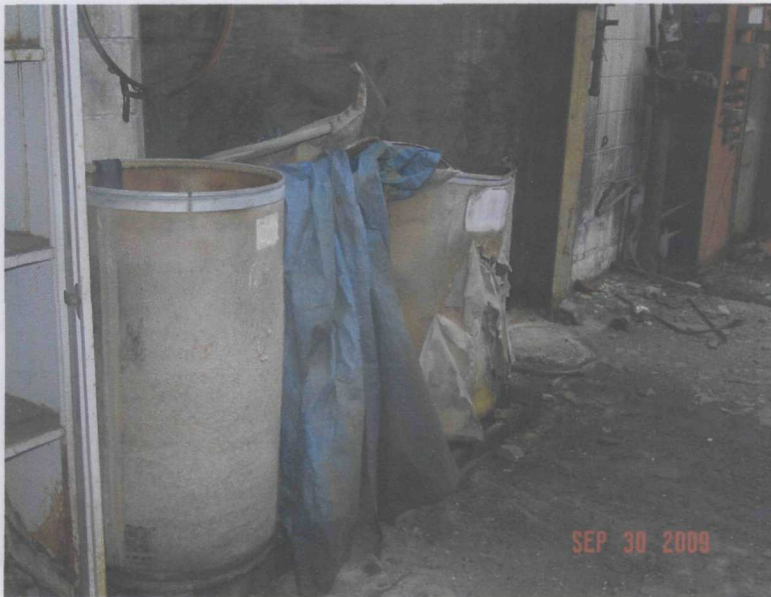
During the September 30, 2009, U.S. EPA Site Investigation, the OSC noted abandoned waste including drums, tanks, containers, and uncontainerized waste piles. Drums were noted to be deteriorated, with contents spilled on the floor and drain areas. The structurally-impaired building is 58,000 square feet with sections of the roof collapsed above waste storage areas. Uncontainerized waste piles surrounded the furnaces and trenches were filled with oil and water. Approximately 75 unknown drums and containers were documented inside the vacant building. Waste piles surrounding the former furnaces contained elevated levels of cadmium (TCLP waste). The OSC noted unrestricted Site access with doors and windows broken. Debris including drums, batteries, wood, waste piles, scrap wire, electrical equipment, vegetation, and trash was scattered inside the building with evidence of trespassing. Oil staining on the building floor was documented in numerous locations due to scrap operations.

Above: View of deteriorated fiber drums containing heavy metals waste.
